# Full Mouth Reconstruction in a Patient with Severely Worn Dentition by Restoring the Vertical Dimension of Occlusion: A Case Report

**T**his clinical report describes the full mouth reconstruction in a patient with severely worn dentition. The treatment plan involved the metal-ceramic complete cast crowns and partial removable dental prostheses. The patient had a loss of vertical dimension of occlusion (VDO) because of severe attrition. We restored the VDO. During the recall sessions, the treatment plan was successful.

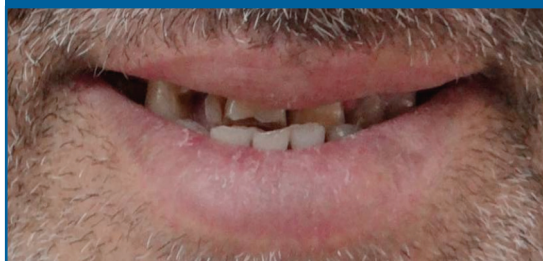
**Fig. 1. Smile view of the patient**

**Clinical report:** A 52-year-old man was presented to our department complaining that he was not satisfied with the appearance of his teeth; his teeth showed progressive wear and he had problems speaking and chewing (Fig. 1).

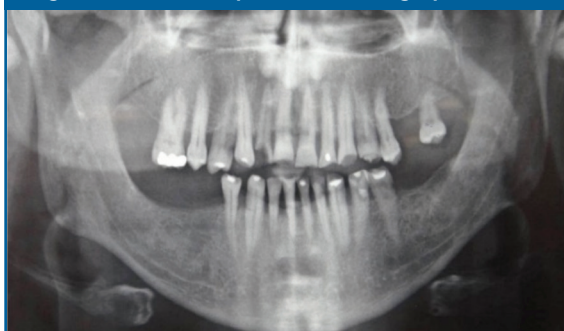
**Fig.2: Pre-treatment panoramic radiograph**

The patient reported that he had previous pocket surgery in both jaws and that some of his teeth had been extracted because of extensive caries and periodontitis. He also mentioned that he had endodontic treatment and amalgam and composite restorations in some teeth because of caries or attrition (Figs. 2 and 3).

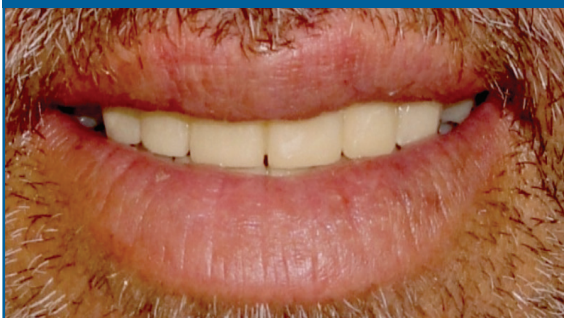
**Fig. 4. Smile view with interim restorations in new VD**

The clinical examination revealed attritional facets on the anterior teeth and premolars in both jaws. There were multiple abfractions and caries in cervical surface of the remaining teeth. The patient had a loss of VDO because of severe attrition. The maxillary left second premolar and molar teeth had an unfavorable crown–root ratio and furcation involvement (Fig.4).

Interim restorations were fabricated after caries removal and primary preparation. The VDO was estimated using several methods, such as phonetics, inter-occlusal distance, and swallowing<sup>5</sup>. The restorations were cemented with non-eugenol zinc-oxide cement (DentoTemp, ITENA, France, Paris). A removable interim prosthesis was fabricated for the mandibular edentulous areas (Figs.6).
